The Pitfalls of the M7 Screw

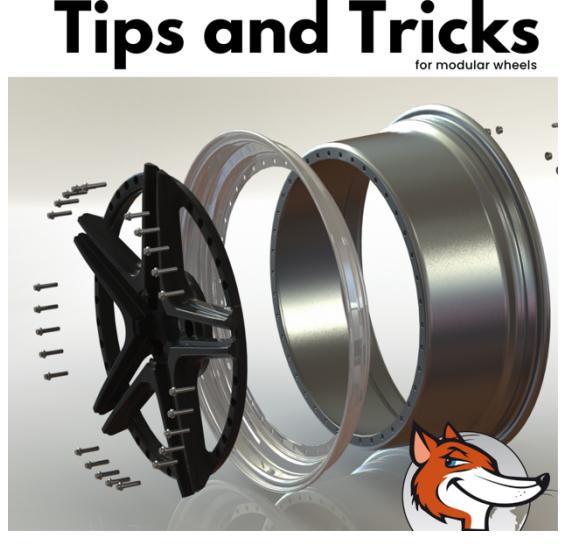
The M7 thread of a wheel screw does not correspond to any DIN standard and is therefore not commercially available. Although specially made for the application of composite wheels, screw breakage still occurs from time to time. Could there be a serious defect in the screw? M7 screws are manufactured in batches of 50,000 pieces, and nuts are produced in even larger quantities. It would be an incredible coincidence if the 20 defective screws were used in just one wheel set from such a batch.

Based on my experience, I would like to draw attention to two noticeable causes of broken wheel screws:

One cause is that the screw is subjected to excessive shear stress when the three components of the wheel are not aligned. To avoid this, each screw should be able to fall loosely through all three wheel components during installation, and the wheel may need to be drilled to a diameter of 7.7 mm if necessary.
Another cause is when the nut or screw head is placed on a thick layer of paint, causing one-sided pressure and negatively affecting the screw connection. After a short distance of driving, the nut or screw works its way into the material, causing the connection to loosen and break.

The final assembly of modular wheels, whether three-piece or two-piece, is critical. If a screw breaks, a flat tire is not far behind... Fortunately, the air usually escapes slowly, and major damage is avoided. Take a day and pay attention to the details when installing your composite wheels.
